# Manhole Inspection Summary

Manhole # **S17C\_\_015MH**

Insp Date: **5/14/09 10:02 AM**

**Location** Address: **2333 LAURETTA-FRANKLIN ALLEY** Cross Street: **BENTALOU ST**

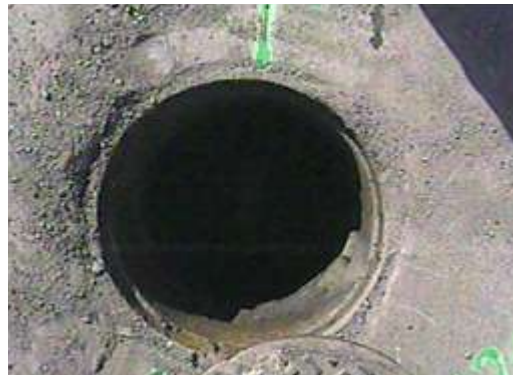
Defect 1

**Frame** Offset: **2** (in.) Condition: ☒ Sound ☐ Cracked ☐ Leaks

FRAME OFFSET

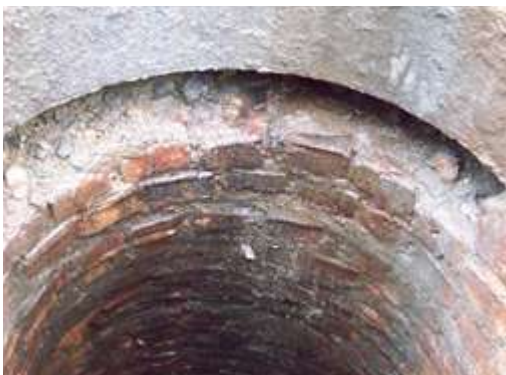
Defect 2

**Chimney / Frame Adjustment** ☒ Exists Material: **Brick** ☐ Parged Height: **4** (in.)

Condition: ☐ Sound ☐ Cracked ☐ Root Intrusion ☐ Loose Brick ☒ **Deteriorated**

CHIMNEY DETERIOTED

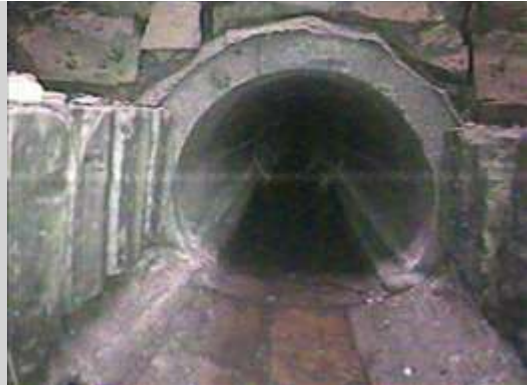
12 O'Clock Outflow

8 in. Circular Gravity Sewer  
Pipe Out @ 12 O'Clock

Pipe Height: (in.) Direct (Angled)  
Pipe Material: **Clay** ☐ Pipe Lined  
Invert Depth: **6.79** (ft.) Flow Characteristics: **Slow**  
Deposits: ☒ None ☐ Mud ☐ Sludge ☐ Debris ☐ Grease  
Silt Depth: (in.) Deposits Extent:  
Infiltration: **None** Pipe Seal Cond: **Sound**

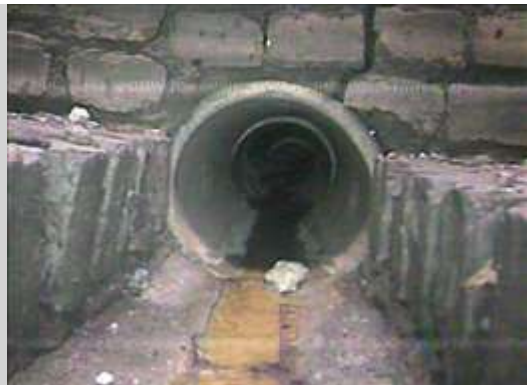
6 O'Clock Inflow

8 in. Circular Gravity Sewer  
Pipe In @ 6 O'Clock

Pipe Height: (in.) Direct (Angled)  
Pipe Material: **Clay** ☐ Pipe Lined  
Invert Depth: **6.69** (ft.) Flow Characteristics: **Slow**  
Deposits: ☒ None ☐ Mud ☐ Sludge ☐ Debris ☐ Grease  
Silt Depth: (in.) Deposits Extent:  
Infiltration: **None** Pipe Seal Cond: **Sound**
